MIFACE INVESTIGATION #05MI077

SUBJECT: Race Car Fuel Dispenser Operator Killed when Methanol Tank Exploded

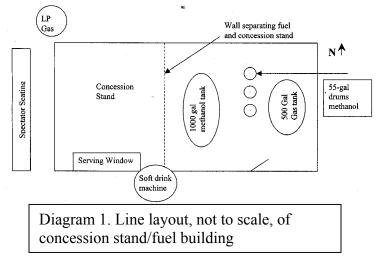
Figure 1. Site of burning storage shed
